# Manhole Inspection Summary

Manhole # S51A\_\_024MH

Insp Date: **2/10/09 9:20 AM**

**Location** Address: **425 CURLEY-POTOMAC-ALLEY**

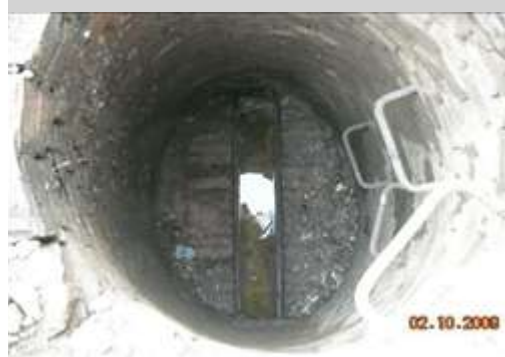
Top View

Type: **Stormwater** Condition: **Sound** Cover Material: **Cast Iron**

Stormwater Lid with holes

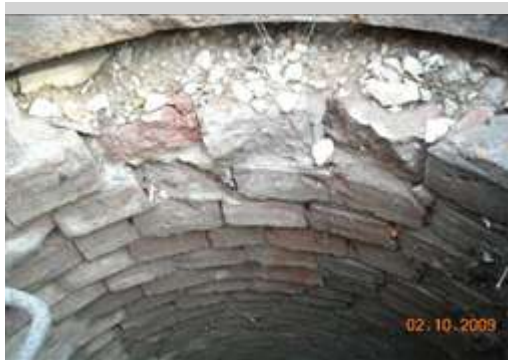
Defect 5

Condition: ☐ Sound ☒ **Cracked** ☐ Root Intrusion ☒ **Loose Brick** ☒ **Deteriorated**

CRACKED CHIMNEY

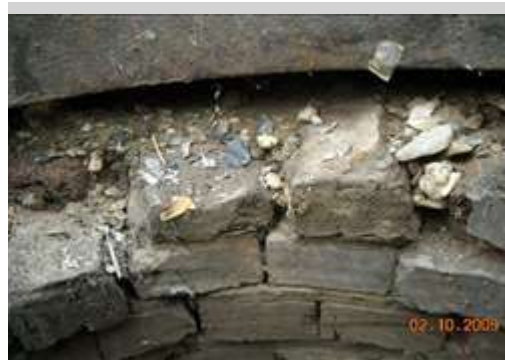
Defect 4

DETERIORATED CHIMNEY

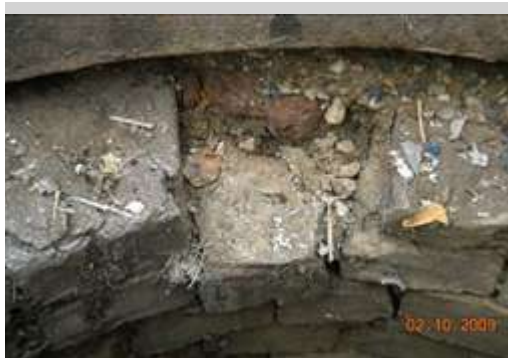
Defect 3

LOOSE/MISSING CHIMNEY BRICKS

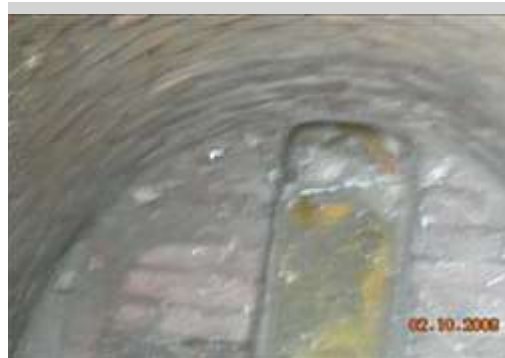
Defect 2

Condition: ☐ Sound ☐ Cracked ☐ Root Intrusion ☐ Deteriorated ☐ Leaks ☒ **Debris**

DEBRIS IN CHANNEL

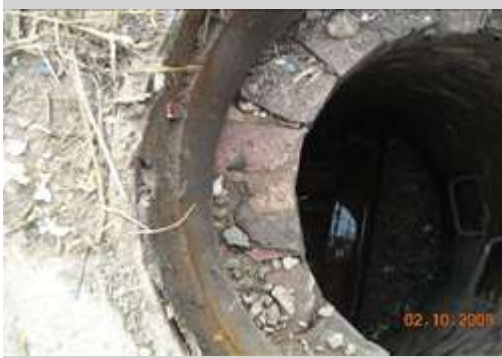
### Defect 1

**Frame** Offset: **5** (in.) Condition: ☒ Sound ☐ Cracked ☐ Leaks

FRAME OFFSET

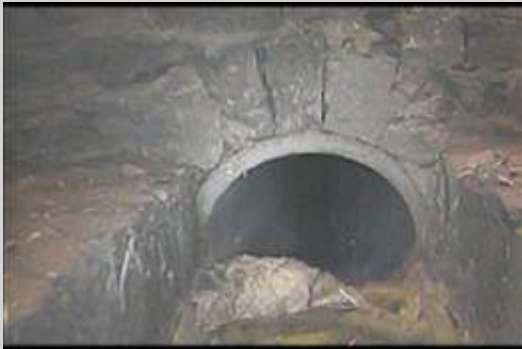
12 O'Clock Outflow

8 in. Circular Gravity Sewer  
Pipe Out @ 12 O'Clock

Pipe Height: **8.4** (in.) Rod and Bar (Angled)  
Pipe Material: **Clay** ☐ Pipe Lined  
Invert Depth: **7.82** (ft.) Flow Characteristics: **Slow**  
Deposits: ☒ None ☐ Mud ☐ Sludge ☐ Debris ☐ Grease  
Silt Depth: **0** (in.) Deposits Extent:  
Infiltration: **None** Pipe Seal Cond: **Sound**

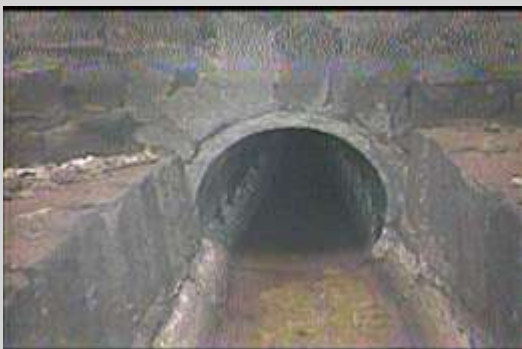
6 O'Clock Inflow

8 in. Circular Gravity Sewer  
Pipe In @ 6 O'Clock

Pipe Height: **8.4** (in.) Rod and Bar (Angled)  
Pipe Material: **Clay** ☐ Pipe Lined  
Invert Depth: **7.78** (ft.) Flow Characteristics: **Slow**  
Deposits: ☒ None ☐ Mud ☐ Sludge ☐ Debris ☐ Grease  
Silt Depth: **0** (in.) Deposits Extent:  
Infiltration: **None** Pipe Seal Cond: **Sound**
